# Manhole Inspection Summary

Manhole # S13S\_\_011MH

Insp Date: **3/11/08 2:46 PM**

**Location** Address: **2900 B Cowan Ave**

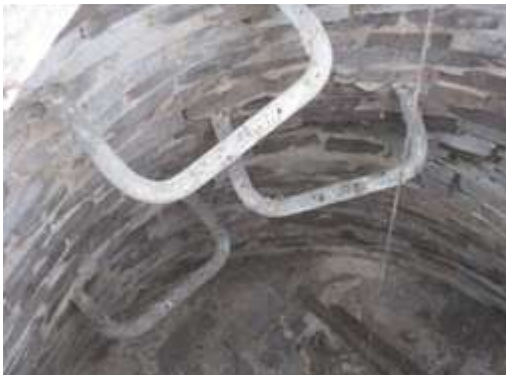
Miscellaneous

steps

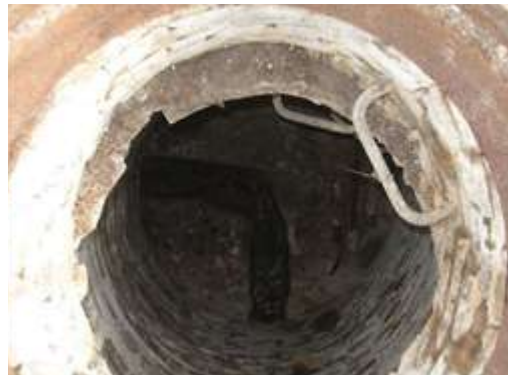
Defect 3

**Frame** Offset: **4** (in.) Condition: ☒ Sound ☐ Cracked ☐ Leaks

Frame offset 3.5"

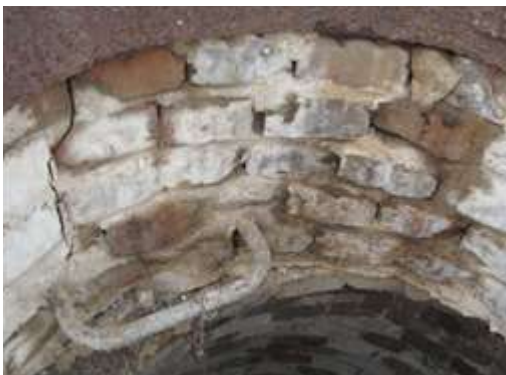
Defect 2

Condition: ☐ Sound ☐ Cracked ☐ Root Intrusion ☒ **Loose Brick** ☐ Deteriorated

cracked and loose bricks in chimney

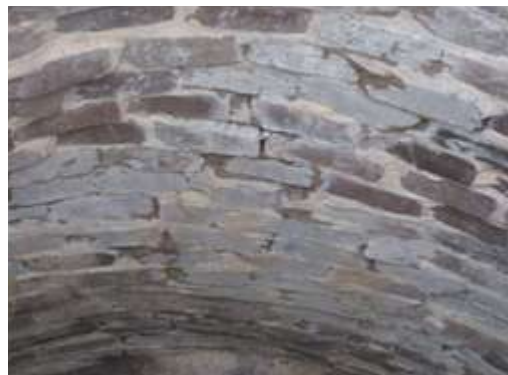
Defect 1

Condition: ☐ Sound ☐ Cracked ☐ Root Intrusion ☒ **Loose Brick** ☐ Deteriorated

loose bricks and mortar in corbel wall

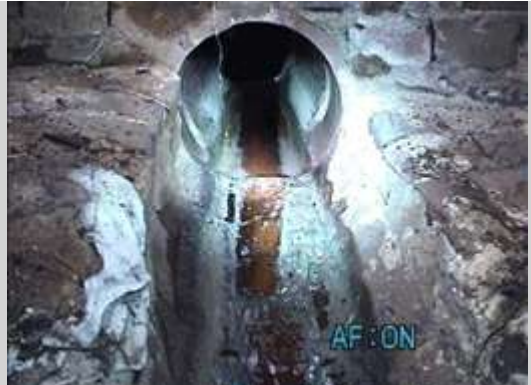
12 O'Clock Outflow

8 in. Circular Gravity Sewer  
Pipe Out @ 12 O'Clock

Pipe Height: **8.4** (in.) Rod and Bar (Angled)  
Pipe Material: **Clay** ☐ Pipe Lined  
Invert Depth: **10.10** (ft.) Flow Characteristics: **Slow**  
Deposits: ☒ None ☐ Mud ☐ Sludge ☐ Debris ☐ Grease  
Silt Depth: **0** (in.) Deposits Extent:  
Infiltration: **None** Pipe Seal Cond: **Sound**

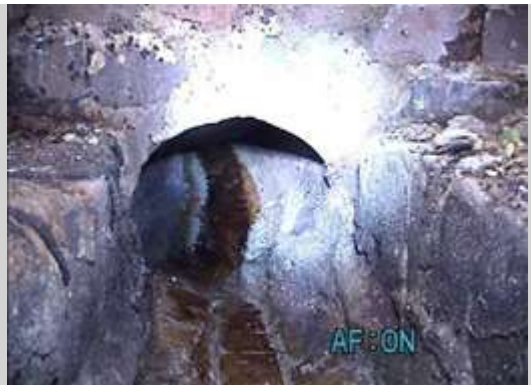
9 O'Clock Inflow

8 in. Circular Gravity Sewer  
Pipe In @ 9 O'Clock

Pipe Height: **8.4** (in.) Rod and Bar (Angled)  
Pipe Material: **Clay** ☐ Pipe Lined  
Invert Depth: **9.18** (ft.) Flow Characteristics: **Slow**  
Deposits: ☒ None ☐ Mud ☐ Sludge ☐ Debris ☐ Grease  
Silt Depth: **0** (in.) Deposits Extent:  
Infiltration: **None** Pipe Seal Cond: **Sound**
